Highway Accident Brief

Collision Between Car Operating with Partial Driving Automation and Truck-Tractor Semitrailer Delray Beach, Florida, March 1, 2019

Accident Number:	HWY19FH008
Accident Type:	Intersection collision involving partially automated vehicle
Location:	Southbound US Highway 441, Delray Beach, Palm Beach County, Florida
Date and Time:	Friday, March 1, 2019, 6:17 a.m. eastern standard time
Vehicle 1:	2018 Tesla Model 3
Vehicle 2:	2019 International truck-tractor in combination with 2008 Vanguard semitrailer
Fatalities:	1
Injuries:	0

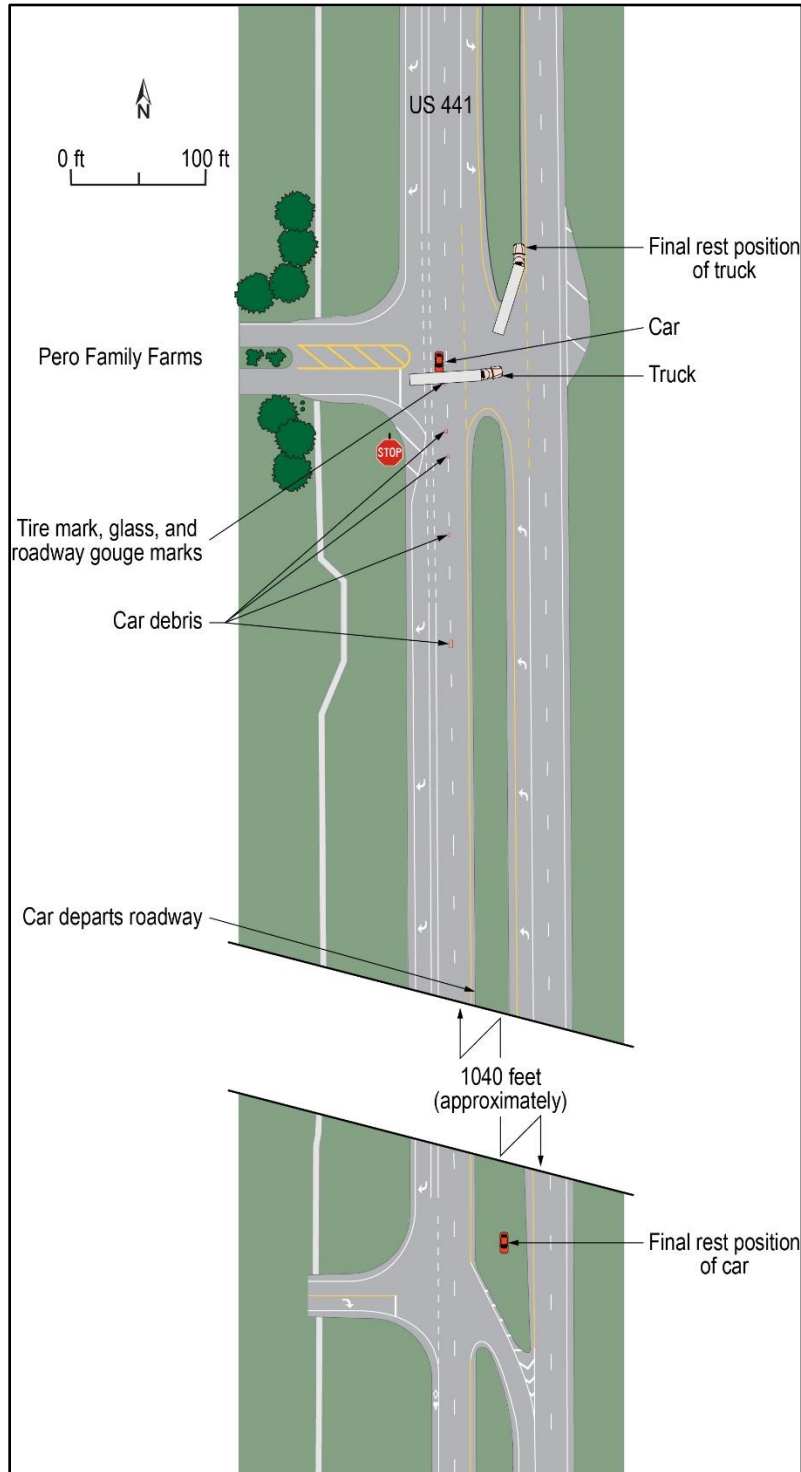
The car hit the left side of the semitrailer just aft of the trailer's midpoint. The roof of the car was sheared off as the vehicle underrode the semitrailer and continued south. Postcrash, the car coasted to a stop in the median between the southbound and northbound lanes, about 1,680 feet from where it struck the semitrailer (figure 1). The 50-year-old male car driver died as a result of the crash. The 45-year-old male truck driver was uninjured.

Figure 1. Diagram showing positions of car and truck at impact and final rest.
